Bulletin No. 5
October de 2015

LIFE · TREMEDAL Nat/Esl/707

Inland wetlands of the Northern Iberian Peninsula: Management and restoration of peatlands and wet environments

Restoration actions implemented as part of the European project
LIFE TREMEDAL

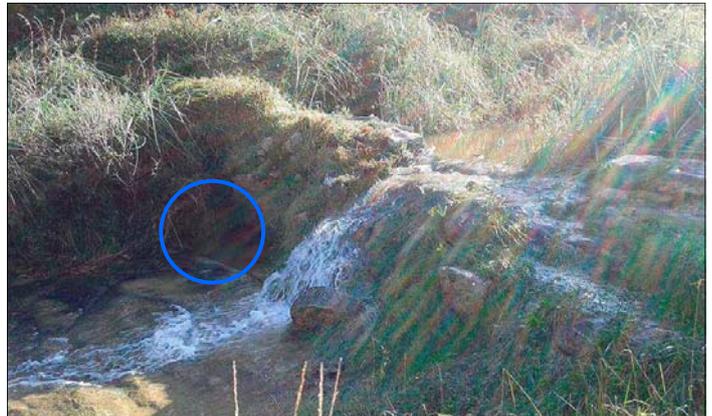
Sluice gate installed and closed to evaluate its performance. The water does not run through the base outlet (blue circle), but flows over the small dyke.

On the basis of this information, a sluice gate was fitted on the base outlet, the administration of which is now being adjusted according to the effects observed. The idea is to keep it closed during the dry months (May to October) and to open it during the rest of the year to permit drainage and leach elements dragged along by the torrent and prevent the wetland from clogging up.

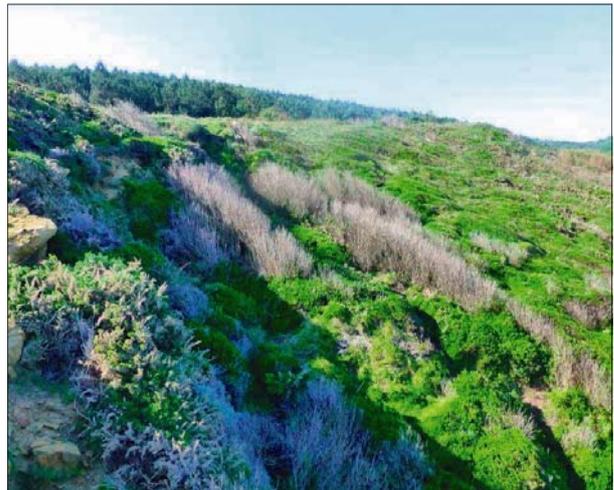
Treated *B. halimifolia* formations. The adjacent formations show no effects of the selective treatment worthy of note.

The entire wetland was thoroughly searched for *Baccharis halimifolia* to ensure that it was free of the plant. Those examples found were selectively treated by applying glyphosate with a brush.

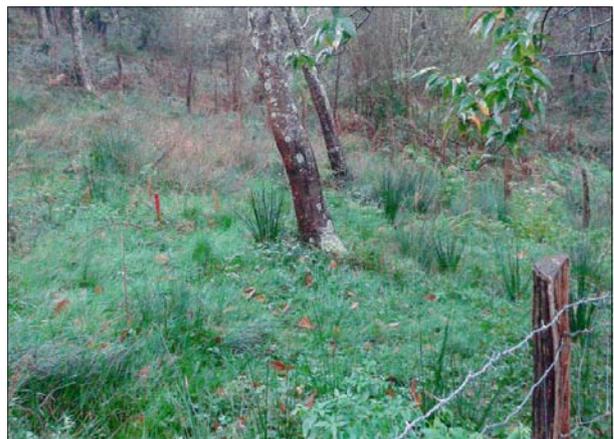
Detail of the area added to the original site, with a permanent monitoring quadrat.

The existing fencing at **Jaizkibel-2** has been left and extended to the adjacent waterlogged ground to allow homogenous restoration of the site.

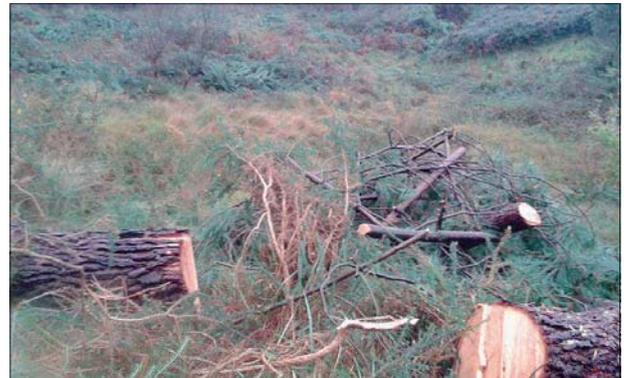
Forestry debris removal in progress (unchopped debris), with part of the wetland in the background.

Forestry clearance work was performed over an area covering approximately 30 metres from the outer perimeter of the wetland without any major hitches. The plant debris was chopped up and left in piles at the site, not being removed from the area.

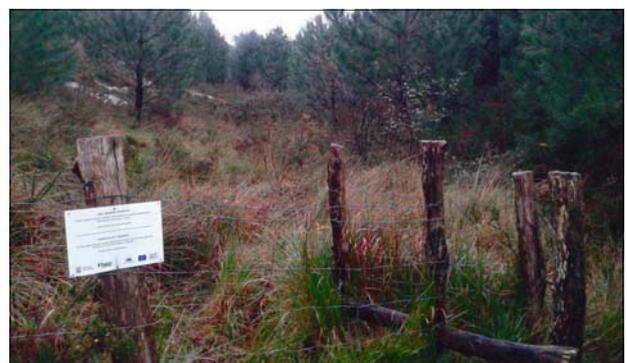
Access to Jaizkibel 4 through the plantation, with the sign indicating that work is under way as part of the LIFE TREMEDAL project.

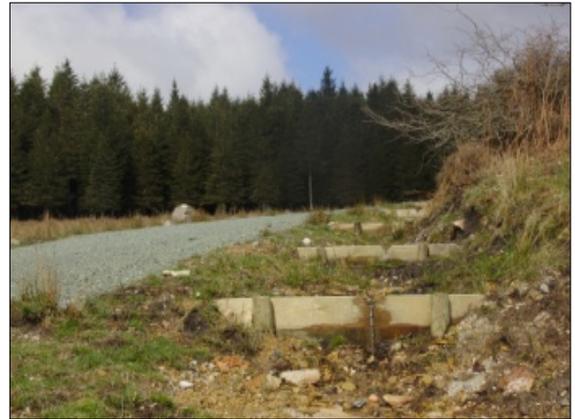
Dykes to check the water in the ditch of the Usabelartza track.

Monitoring of the effects of these measures (sealing off drainage ditches and work on the forest track to return the water which used to naturally feed the peatland to its course) is on-going.

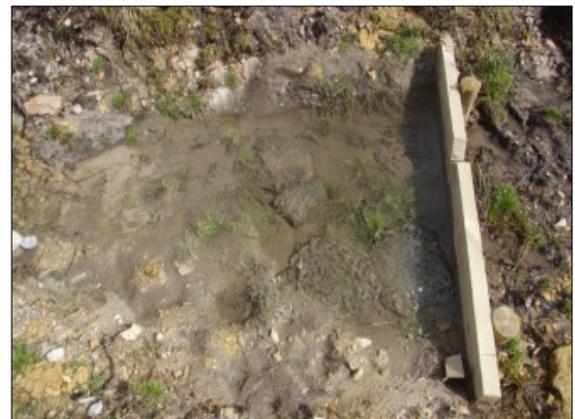
Amphibians make use of the small pools formed by the dykes in the ditches at the Usabelartza site. Detail of *Rana temporaria* spawn

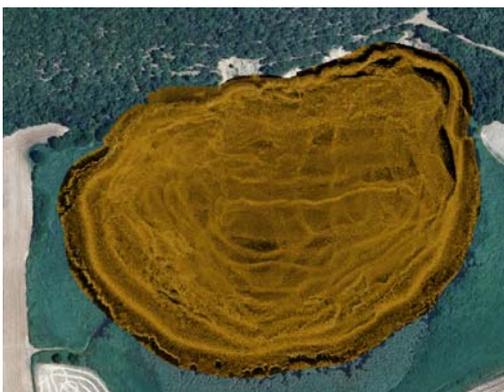
Routes of the sonar study performed in the lake.

In the study, which combined sonar techniques with underwater filming, areas in which aquatic vegetation could potentially develop in the present situation were contrasted and the current species composition was described. This will provide a reference for future monitoring of plant development in response to actions taken to combat invasive aquatic species in the Lake.

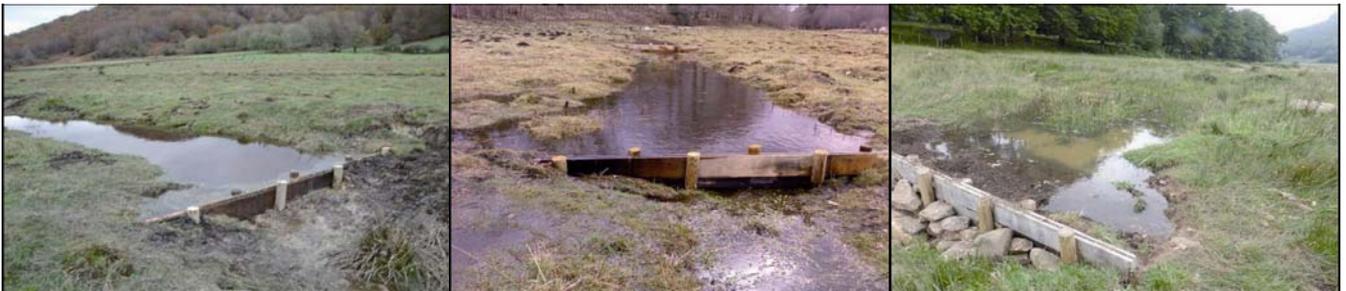
Wooden dyke showing its clay reinforcement.

Effect of the structure, which retains the water on one side and favours waterlogging in the surrounding area on the other.

Wooden posts in staggered formation to secure the dyke to the ground. In this case, stones have been added downstream to prevent erosion caused by the falling water.

Thick planks (7-9 cm thick) with tongue-and-groove joints were positioned across the water flow at strategic points previously selected on the basis of a detailed survey. These structures were reinforced and secured to the ground via wooden posts set in staggered formation. Clay was added to enhance their impermeability.

At the **Belate Mire**, for example, where dykes of this kind had not been used before, 4 have been built.

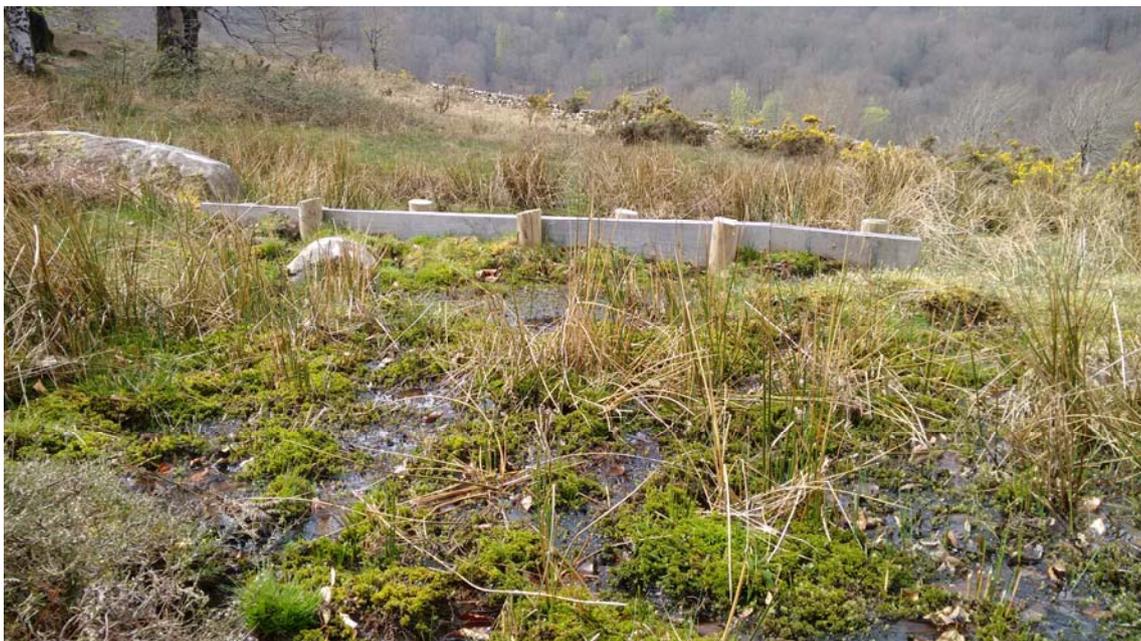
Plant development upstream from the dyke one year after installation.

8 wooden dykes have been erected at the **Lixketa Mire**.

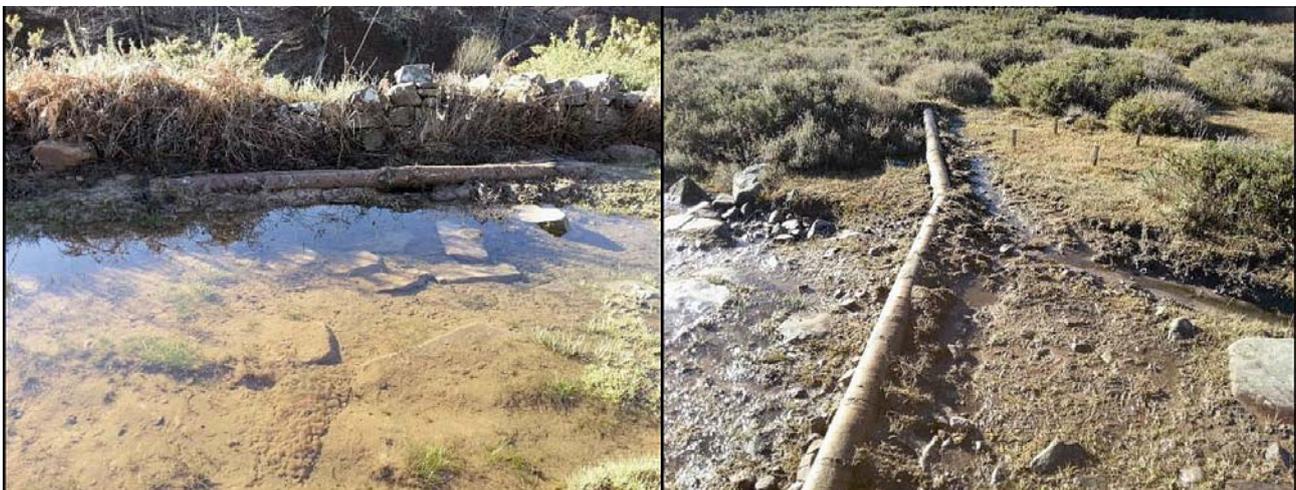
Left: The main outlet point from the wetland, which waterlogs a section of track covering 150 m².

Right: Wooden poles divert the water from the track to a flat area of 500 m² with great potential for the development of peatland vegetation. The vegetation monitoring plot is also visible.

In order to restore the area affected by all-terrain vehicle traffic at the **Maulitx Mire**, motor vehicle traffic has been prohibited and 3 dykes made using tree trunks have been installed on 3 sections of the track which runs through the wetland. In each case, small dams were built by hand using trunks with diameters of 20 cm, reinforced with earth.

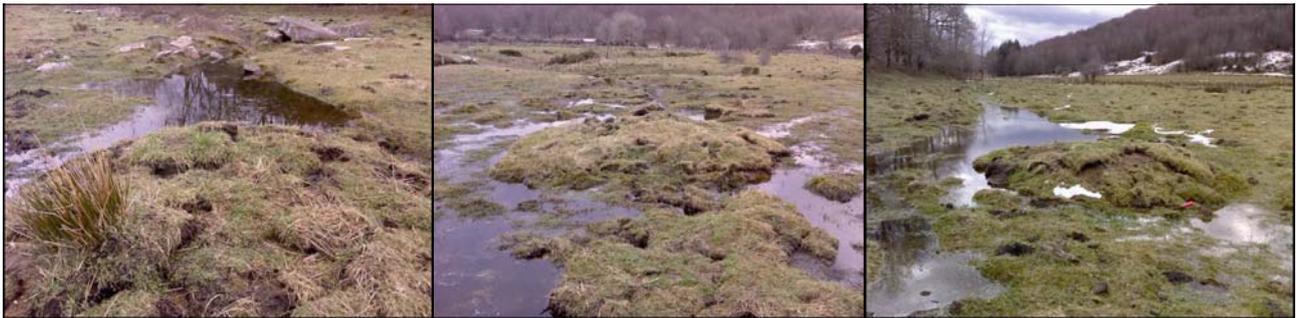
Earth dyke: The dam effect produced can be observed.

A channel plugged and dispersed by earth. The water surfaces and waterlogs a large strip of land.

Earth dyke at the head of an outlet channel and its effect. The sods placed on top of the dyke are clearly distinguishable.

In addition to wooden dykes, earth **dykes** have been built and certain sections of the outlet channels have been filled in at some mires. This work was performed by hand using shovels and wheelbarrows. All the earth used came from the excess generated by the track correction work. Work began by removing the plant layer in the area to be filled in. The sods were kept for later use. The earth was deposited in layers of 20 cm and compacted (by hand) until the required level was reached. The sods set to one side were then put back on top of the area filled in to prevent erosive processes.

Earth dykes have been built and the outlet channel has been filled in, for instance, at the **Belate Mire**, where two pre-existing main outlet dykes have also been reinforced to allow livestock to cross the wetland more easily. This action has considerably improved the wetland's water retention capacity, raising the water table and favouring the flooding of a large area of ground.

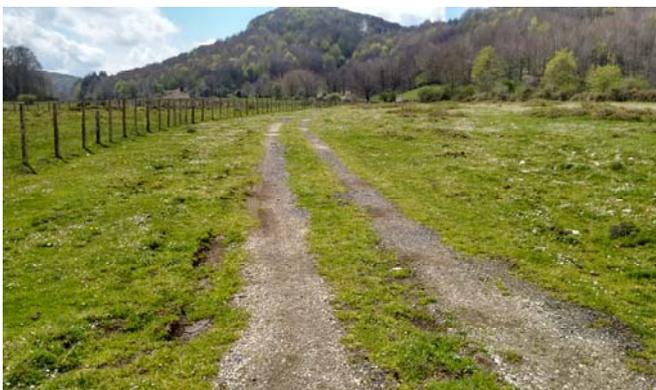
Improvements made to the track in Belate.

The track leading to the fencing around the **Belate Mire** has been corrected, improving two wheel ruts so that all vehicles can use them and no new ones need be formed; a base of ballast up to 40 cm thick has also been laid to improve the points where the track crosses brooks.

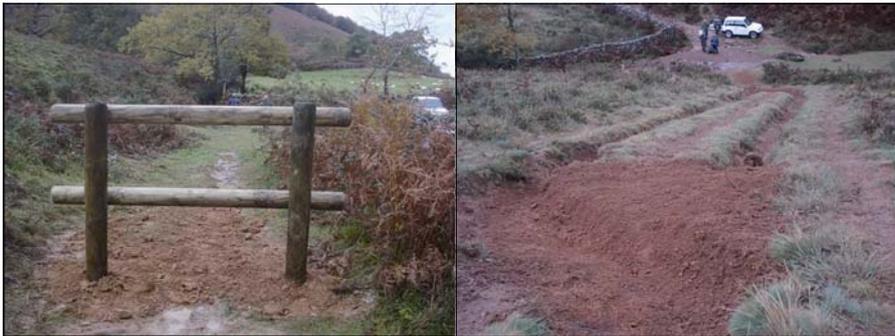
From left to right:
Barrier to prevent vehicles from passing.
Crosswise drainage to divert torrent water to the track drainage system.

The action taken at the **Maulitx Mire** involved installing three small barriers consisting of two 1-m posts with sections of 12 cm made of treated wood, secured with concrete. The distance between the posts, 1 m, prevents motor vehicles from accessing the area. The posts are joined by two round wooden fence rails.

The drainage of the track which goes around the wetland has also been improved on a section with a steep slope by digging crosswise drainage into the earth.

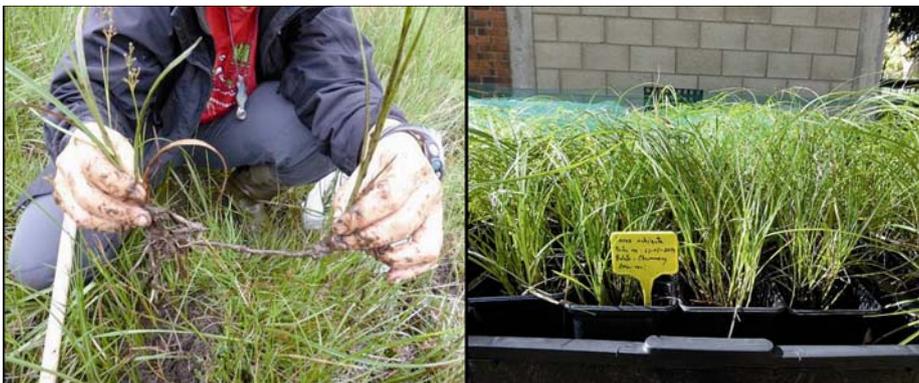
The species collected from the **Belate Mire** and produced in the nursery are: *Eriophorum angustifolium*; *Carex echinata*; *Erica tetralix*; *Sphagnum* spp.; *Narthecium ossifragum*; and *Carex hostiana*.

Left: Plant material being collected at the Belate Mire.
Right: State of *Carex echinata* plants after two months in the nursery.

Plant material belonging to different species was gathered from some of Navarre's mires and wetlands. This material was replanted in growing trays with blond peat (100% natural substratum) and placed in the shade at the Miluce nursery (Pamplona). The results have proved satisfactory (practically no failures) and some of the plants have grown quite considerably.

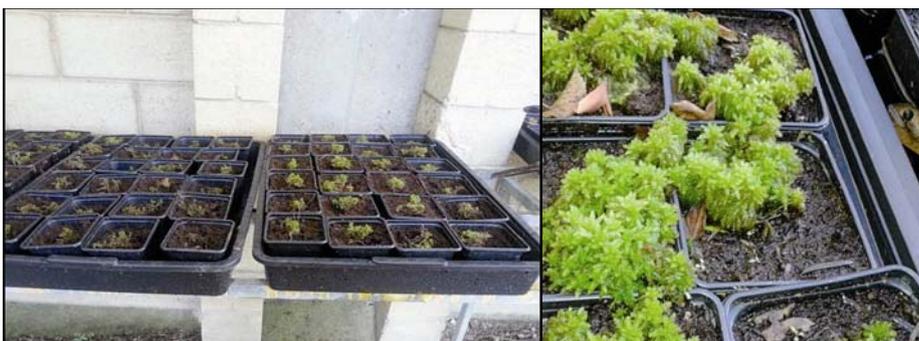
The species collected from the **Xuriain Mire** and produced in the nursery are: *Sphagnum capillifolium* and *Juncus squarrosus*.

Left: Sphagnum recently planted in trays at the Miluce nursery in 2014.
Right: Sphagnum at the end of the winter 2014-2015

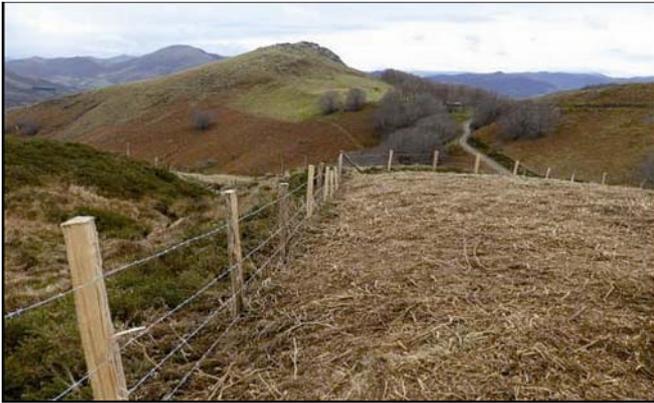
Alkurruntz Mire: Detail of the fence separating the wetland (right) from the water intake and tank (left). Part of the cleared area can also be distinguished.

A new fence measuring 120 metres has been erected at the **Alkurruntz Mire**, dividing the existing fenced-off area into two zones: one with the main part of the wetland and the other with the water intake and tank.

A rustic wooden fence consisting of vertical posts was chosen. The posts were driven into the earth every 2 m to depths of up to 50 cm, meaning that the final height of the fence is 1.2 m, sufficient for the intended purpose.

Work was completed by fitting 4 lengths of galvanised double-strand barbed wire and a length of smooth wire at the top, secured with wire staples and fitted with systems to prevent birds and bats from colliding with the fence.

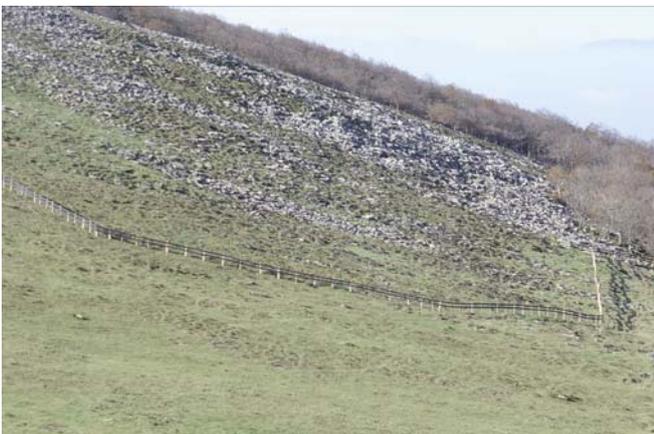
Xuriain Mire: Wooden perimeter fence.

A rustic fence has been erected at the **Xuriain Mire** using split wooden pickets measuring 1.8 m. The posts were driven in to a depth of up to 50 cm every 1.5-1.8 metres, making for a final fence height of 1-1.3 m, enough to prevent the passage of livestock.

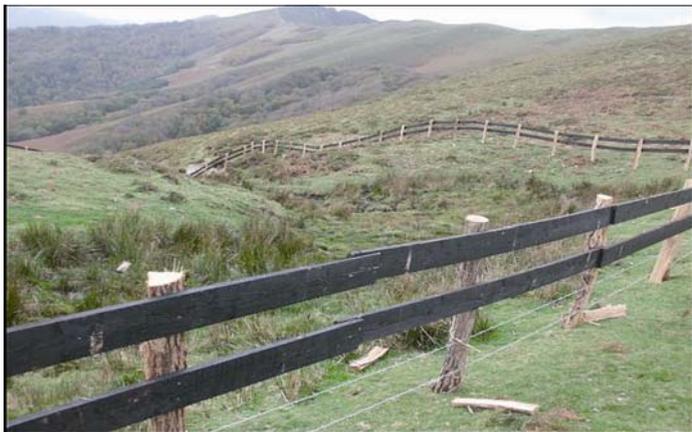
Perimeter fence erected at **Mendaur**

At the **Mendaur Mire**, a 147-m fence similar to those installed at the Arxuri and Xuriain Mires has been erected. The fence consists of wooden posts every 1.5 metres and two creosoted planks fitted horizontally.

The fence was completed with two lines of barbed wire between the ground the first plank to prevent sheep from passing. A wooden gate has been fitted to control the access of livestock to the wetland. Unless impact is observed at the wetland as a result of the presence of livestock, the gate will be left open all year round.

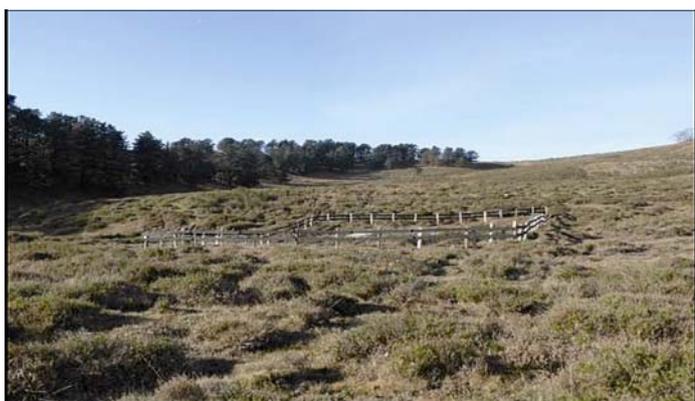
Arxuri Mire: One of the fences, in the area where *Spiranthes aestivalis* was detected.

Two small wooden fences have been erected at the **Arxuri Mire**, one measuring 100 m in the area in which the presence of *Spiranthes aestivalis* was verified, and the other measuring 110 metres around one of the main peat deposits frequently used by livestock. The aim in the second area is to analyse the impact of livestock (trampling and grazing) on the development of species typically found in peat environments in the area.

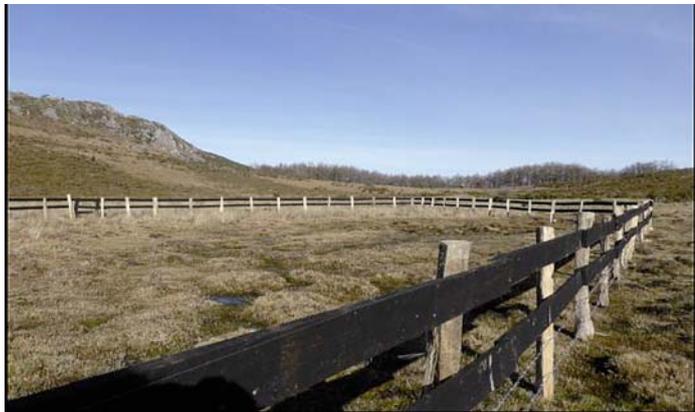
Arxuri Mire: Second fence, in the part of the mire where greater livestock presence was registered.

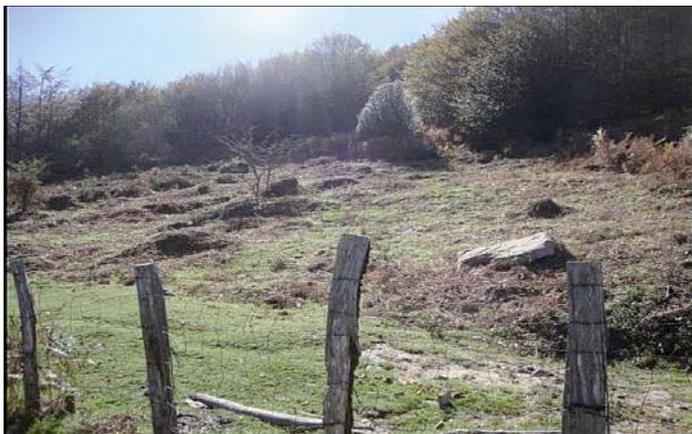
Belate Mire: Cleared area on Giltxurrinarri.

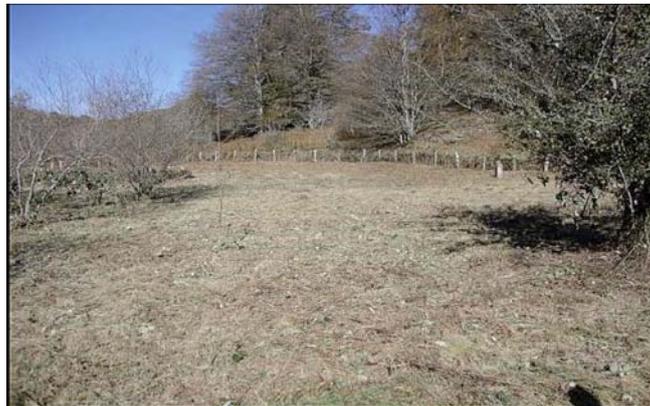
Belate Mire: Cleared area.

Selective vegetation clearance work has been carried out on the central promontory of the **Alkurruntz Mire** using motorised brushcutters. The clearance work, which was selective and uneven in nature, was carried out more intensely in those areas with edaphic humidity.

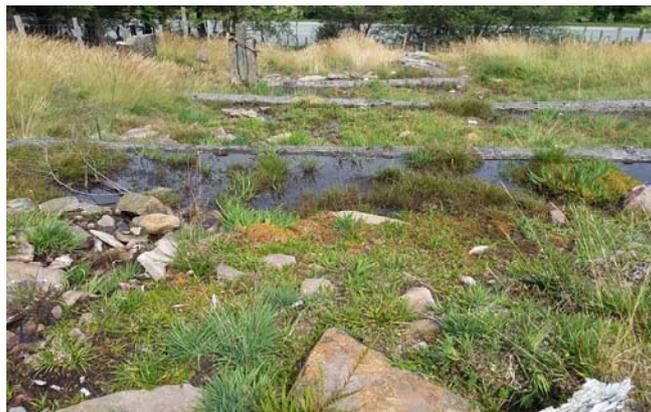
Belate Mire: Dyke made of tree trunks.

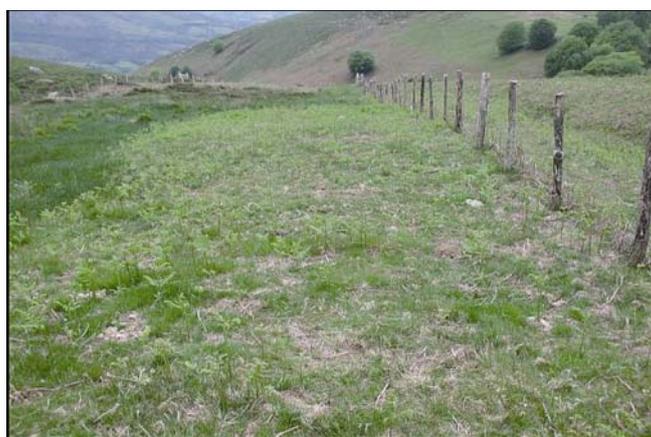
Alkurruntz Mire: Cleared area photographed in spring 2014. Grass development can be observed in areas previously occupied by *Ulex europaeus*.

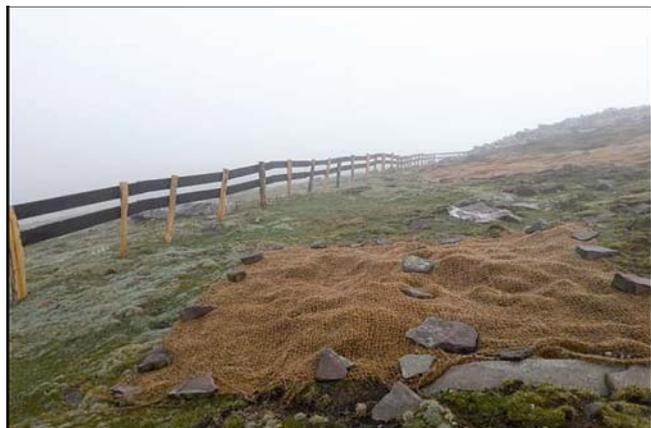
Xuriain Mire: Natural-fibre mesh protecting eroded areas at the Xuriain site. The mesh is secured with corrugated steel rods and local stones.

1,500 m² of natural-fibre mesh has been laid out in highly eroded areas where the peat is not protected by plant cover at the **Xuriain Mire**. Before the mesh was fitted, the land was prepared, removing as many sharp edges and stones as possible. Sections of mesh measuring 2 x 5 m were then laid out in grid formation. The mesh was secured using ground staples and stones to hold it down properly.

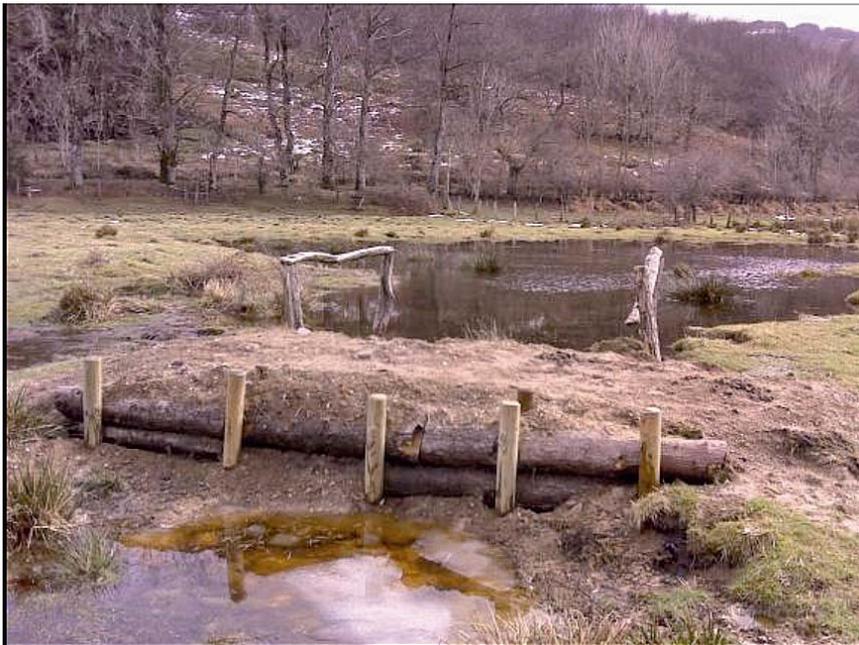
Belate Mire: Recently constructed livestock crossing with right-hand side flooded

Another LIFE TREMEDAL objective was to make different uses compatible in the different peat-forming environments. Action has been taken in this regard at the **Belate Mire** in Navarre, where 2 livestock crossings have been built with earth and tree trunks over the outlet channel on the Baztan side of the mire, dividing the grazing land into two halves. The idea was to stop livestock from crossing, and thereby jeopardising, the wooden dykes in place since 2008, thanks to which the area had become more waterlogged. These dykes have now been reinforced and the waterlogged area has increased and the vegetation has improved.

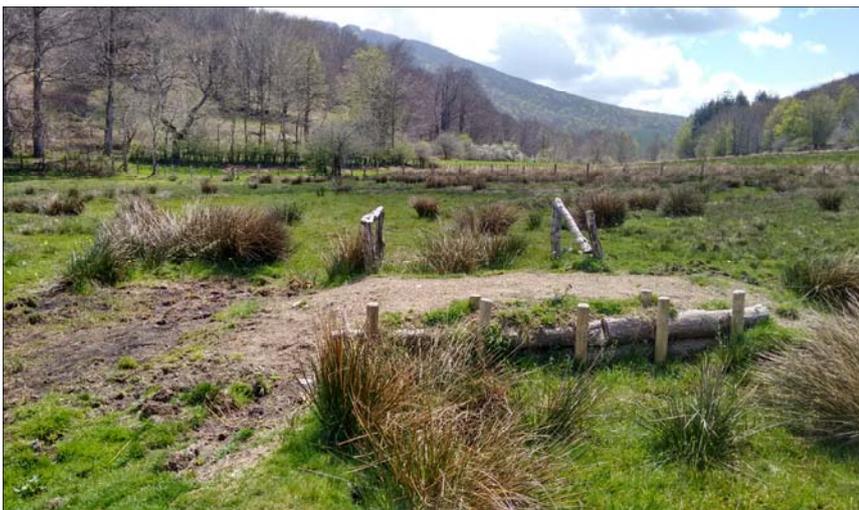
Belate Mire: The livestock crossing some time later.
