Bulletin No. 4 September 2015

Inland wetlands of the Northern Iberian Peninsula: Management and restoration of peatlands and wet environments

Restoration actions implemented as part of the European project LIFE TREMEDAL

Restoration actions implemented at Vega de Comeya and Vega de Liordes (Picos de Europa National Park) as part of the European project LIFE TREMEDAL

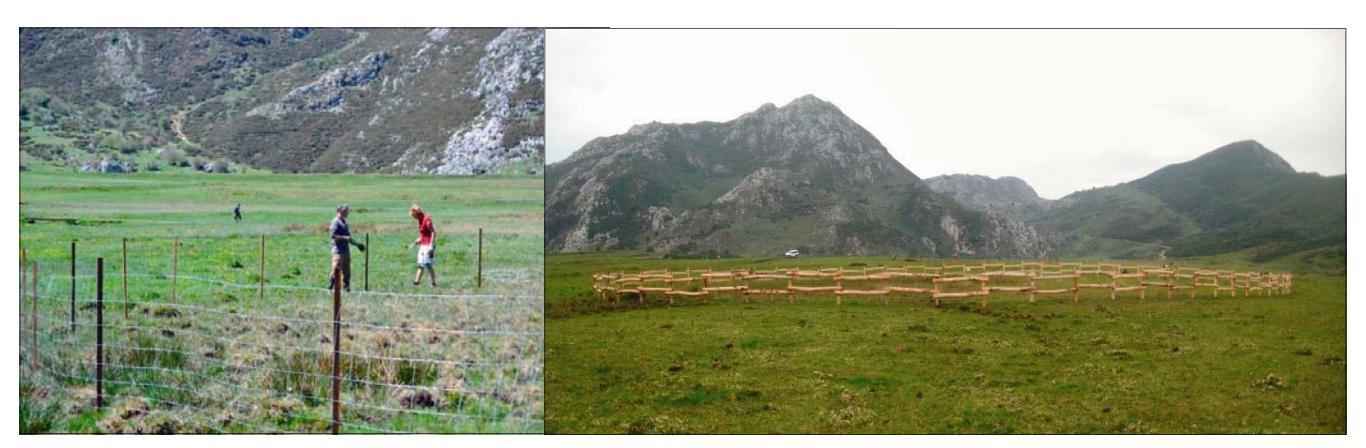
Fencing in Vega de Comeya. Left: Erection of metal fencing. Right: General view of the wooden fence.

This action consisted of installing three fences at mire plots to keep livestock out. In Comeya, two fences consisting of metal posts and barbed wire, protected by electric wiring, were erected first (757.17 m² and 739.98 m²), followed by a third wooden fence to close off the larger plot (1319.19 m²).

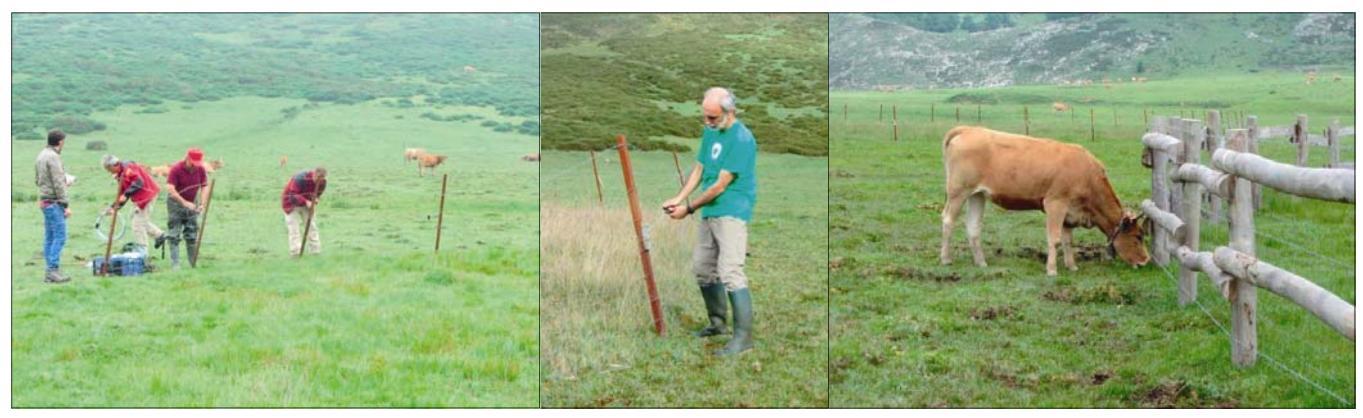
Inspecting the state of the fences.

The fences were checked at the end of spring to see if they had been damaged by snowfall, storms, livestock or vandalism. The state of the electrified wiring and the charges of the batteries supplying it were also checked.

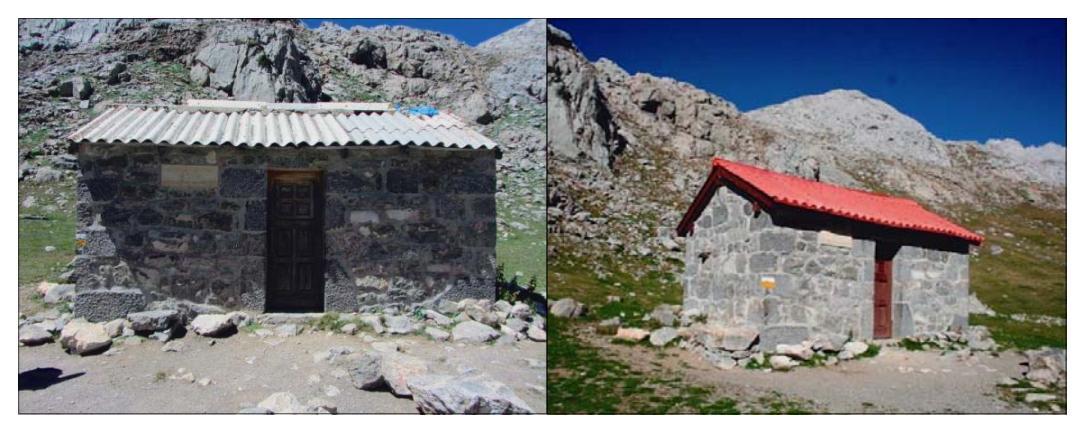
Left: previous state. Right: current state of the farmers' hut in Liordes following repair.

In Liordes, a hut used by local farmers as a shelter in bad weather or in the event of other types of emergency was restored. It was re-roofed, its walls were repaired and a rudimentary bed was installed.

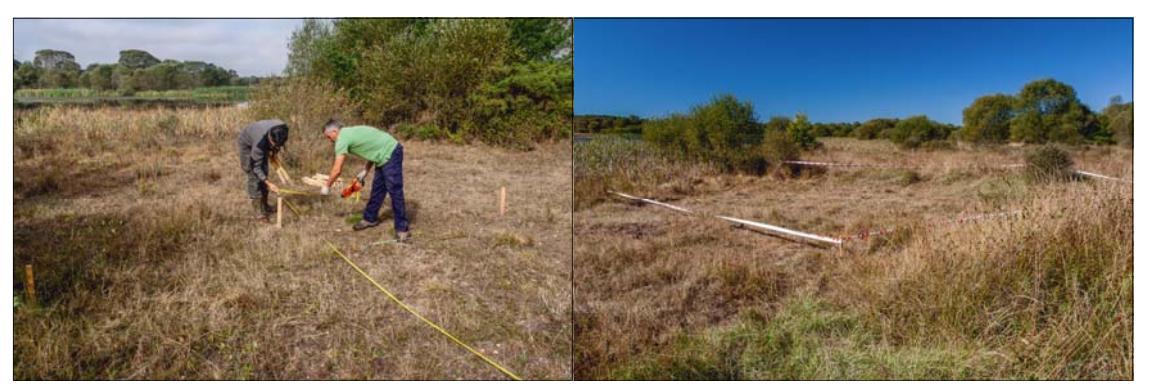
Left: marking out the area of action. Right: area delimited due to the presence of protected species.

In this initial stage, the area of action was delimited and the pools which were going to be created were marked out. Once the presence and absence of protected species had been verified in the area of action, the different areas were suitably cordoned off so that the work would not affect them. The conditions according to which machinery and operators could move through sensitive areas at the site were also established.

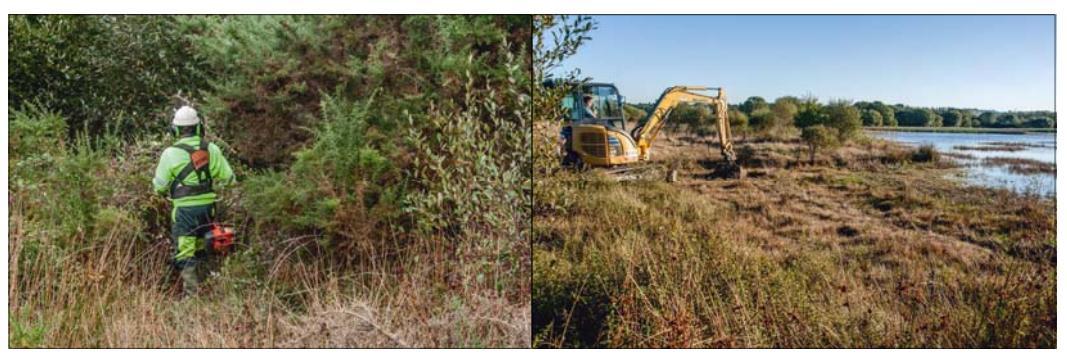
Left: vegetation clearance work in the Wetland of Cospeito using hand-held tools. Right: vegetation clearance work in the Wetland of Cospeito using construction machinery.

The work involved in this second stage was performed using both handheld tools, brush cutters and chainsaws, and small construction machinery (a minidumper and a small backhoe loader). The plant material was removed.

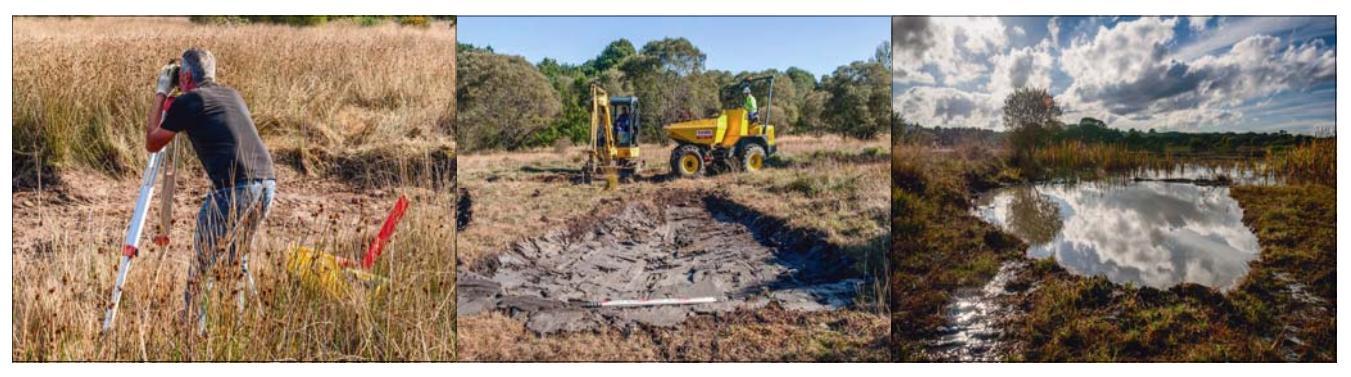
From left to right: operator using the high-precision digital level to landscape the terrain exactly. Work at one of the pools created in the Wetland of Cospeito. View of one of the pools following the first autumn rains.

All the work was performed using light construction machinery, two minidumpers and a small backhoe loader, with the aid of a high-precision digital level.

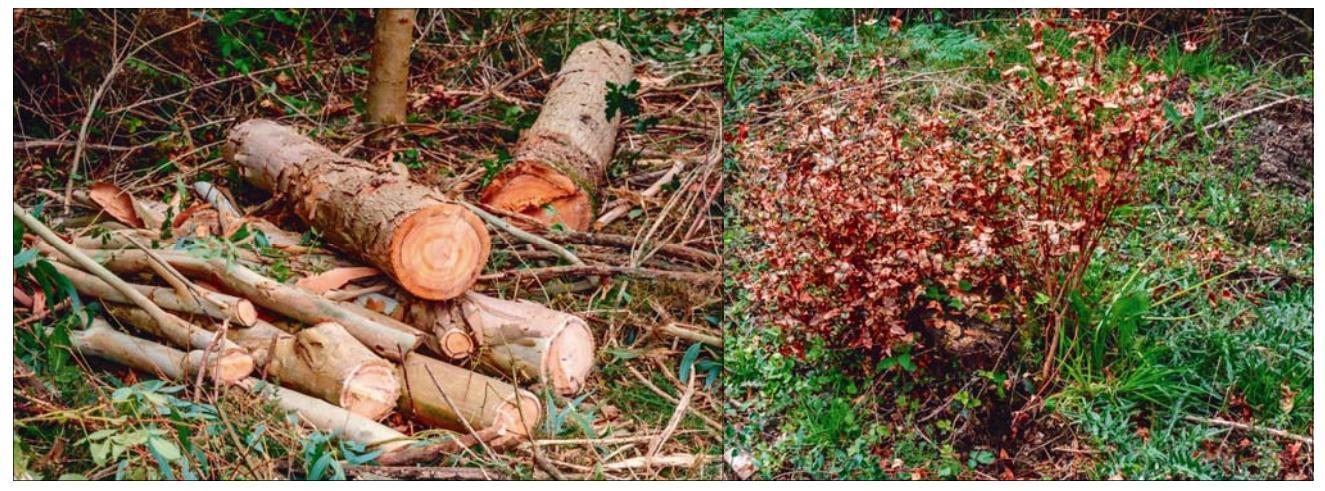
Left: Eucalyptus sp. trunk chopped up. Right: shoots on a Eucalyptus sp. stump in the Wetland of Cospeito.

The numerous examples of *Eucalyptus sp.* Present were removed from the site by chainsawing the trunks and then carrying them away with a forwarder. Given the sensitive nature of the site, chemical control methods were not used on the stumps. The area will be visited each year to eliminate any stump shoots.

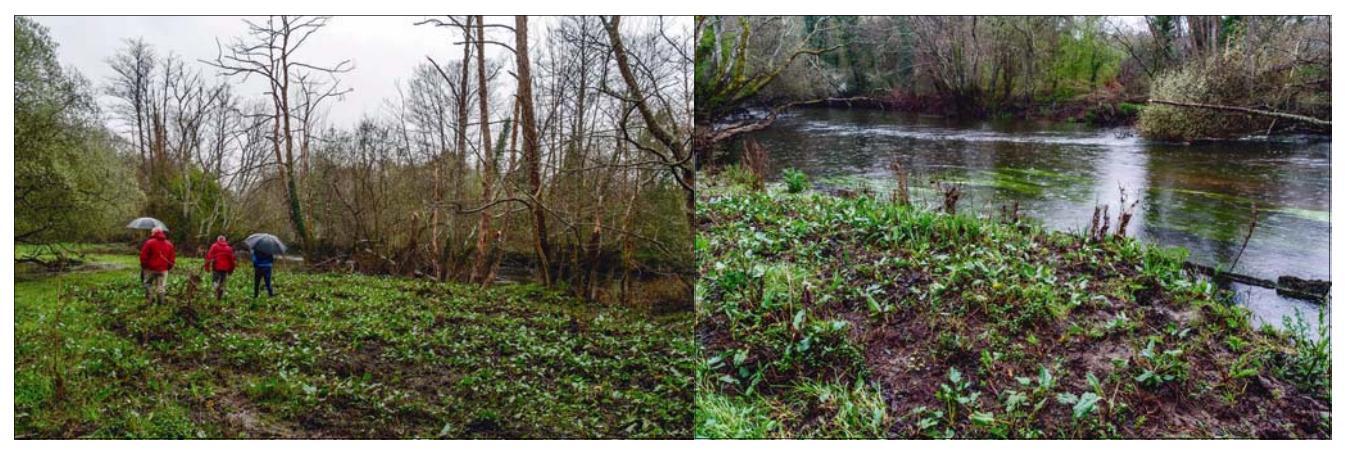
Left: dried out alder trees at the rear of one of the plots in the south of the Island of San Roque. Right detail of the bank devoid of trees and shrubs at one of the sites in the south of the Island of San Roque.

Special attention was paid to the waterside woodland fringes in the plots due to the damage caused to them by the plant pathogen *Phytophthora alni*. More plants were staked in these areas than further inland in order to stabilise the banks, which were suffering from severe erosion.

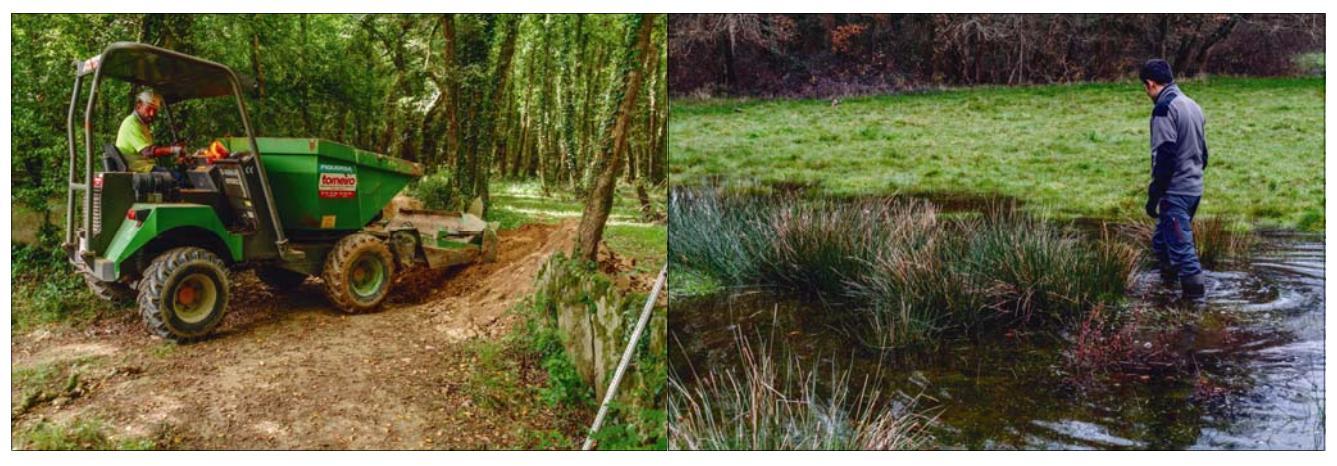
Left: Dumper with front loader working on the Island of San Roque. Right: inspection of the work. Small marshy hollow.

As in Cospeito, the work performed to improve the heterogeneity of these wet habitats consisted of delimiting the areas of action, clearing the vegetation and topographically correcting the terrain (recovering small channels and depressions).

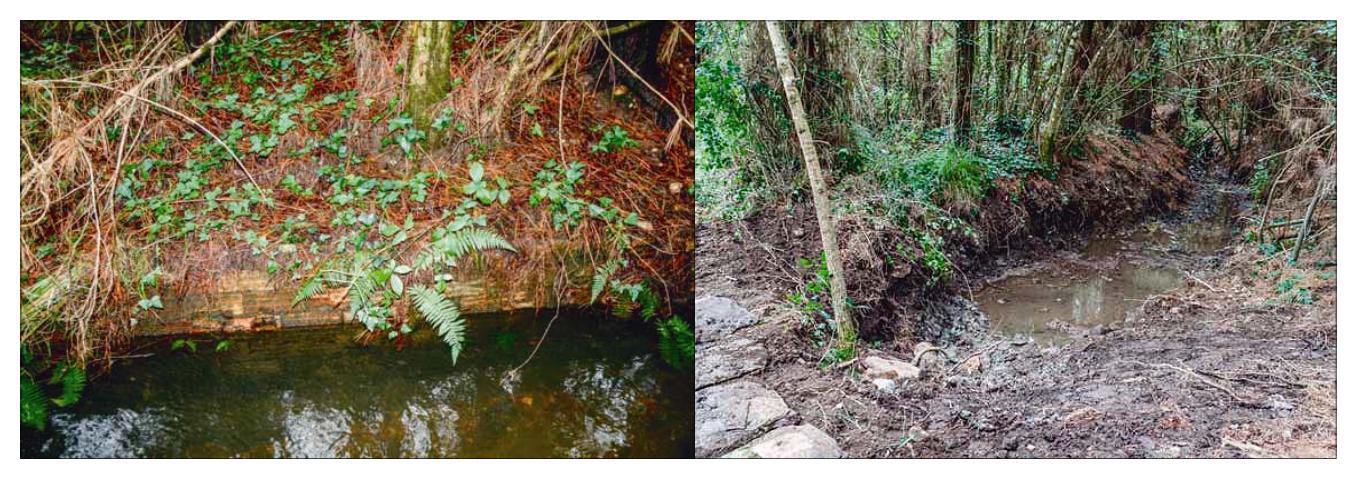
From left to right: pre-existing remains of the old washing place at Ollo Pequeño. View of the washing-place channel with the remains removed.

On the edge of Ollo Pequeño, affected by diversions of water to supply an old washing place, earth was used to block the channel and a traditional stone wall (chantos) was built as reinforcement. Examples of Salix atrocinerea were planted and staked to naturalise the environment.

The topographic correction work was performed with the aid of a high-precision digital level. The work involved was carried out using both handheld tools, brush cutters and chainsaws, and small construction machinery (a minidumper and small backhoe loader). The remains of the old washing place were removed.

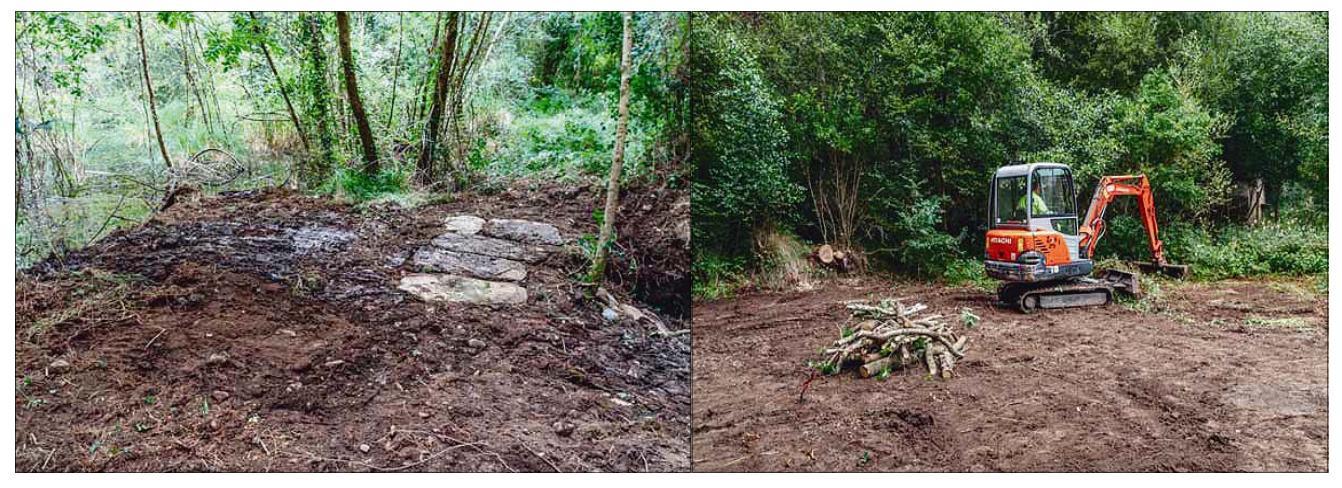
From left to right: detail of the recovery of the edge of *Ollo Pequeño* using "chantos". Vegetation clearance, topographic correction and land preparation at Ollos de Begonte.

The area was then topographically corrected to favour the formations of saw-sedge (*Cladium mariscus*) and the species was planted out.
